# Manhole Inspection Summary

Manhole # S27E1\_005MH

Insp Date: **4/17/08 10:08 AM**

**Location** Address: **BEHIND 2802 MAISEL ST.**

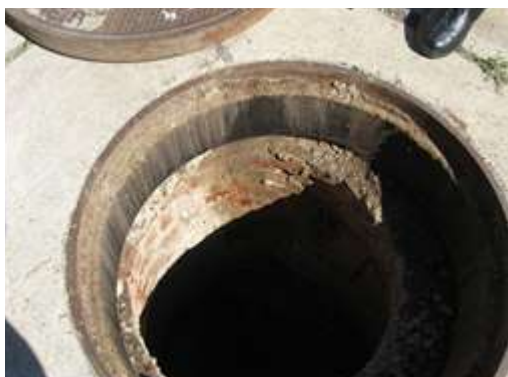
Defect 5

EVIDENCE OF CHIMNEY  
INFILTRATION

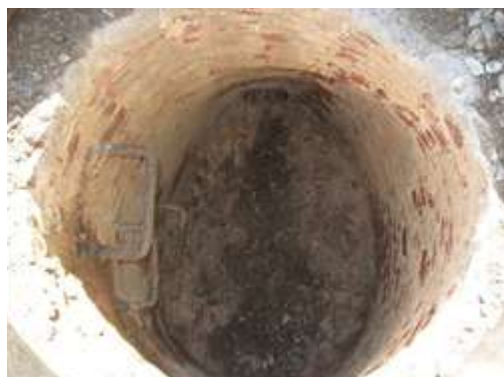
Defect 6

infiltration wall

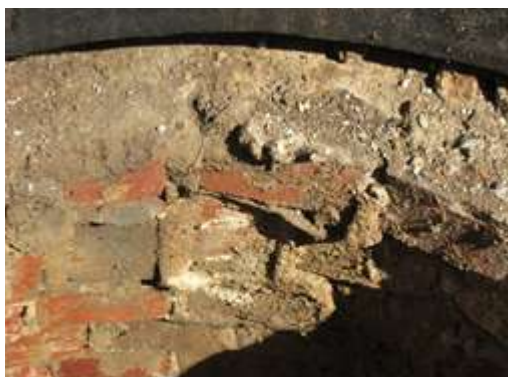
Defect 4

Condition: ☐ Sound ☐ Cracked ☐ Root Intrusion ☐ Loose Brick ☒ **Deteriorated**

MISSING MORTAR CHIMNEY

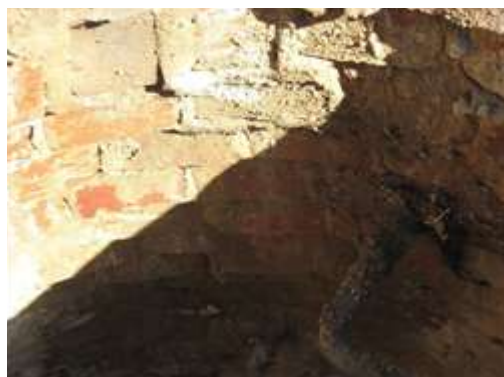
Defect 3

Infiltration: ☐ None ☐ Joint ☐ Cracks ☒ **Mortar** ☐ Roots ☒ **Wall**

MISSING MORTAR WITH EVIDENCE  
OF CORBEL INFILTRATION

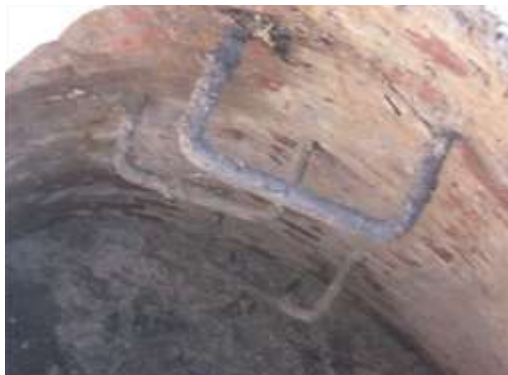
Defect 2

**Steps** Count: **3** Missing: **0** ☒ **Corroded**

CORRODED STEPS WITH EVIDENCE  
OF CORBEL AND BARREL  
INFILTRATION

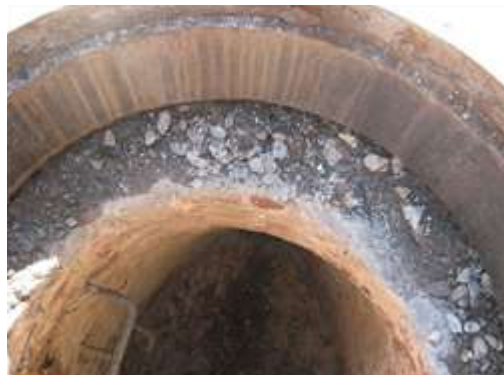
Defect 1

**Frame** Offset: **5** (in.) Condition: ☒ Sound ☐ Cracked ☐ Leaks

5 IN FRAME OFFSET

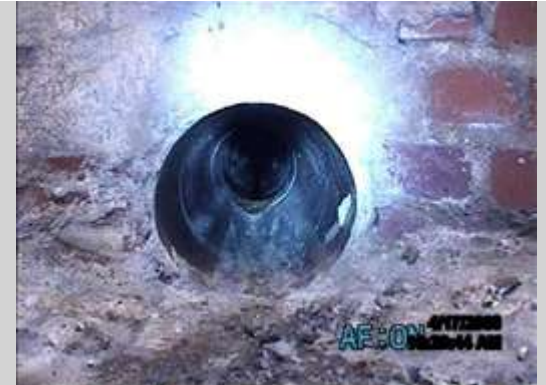
12 O'Clock Outflow

8 in. Circular Gravity Sewer  
Pipe Out @ 12 O'Clock

Pipe Height: **8.4** (in.) Rod and Bar (Angled)

Pipe Material: **Clay** ☐ Pipe Lined

Invert Depth: **6.60** (ft.) Flow Characteristics: **None**

Infiltration: **None** Pipe Seal Cond: **Sound**
